Manhole Inspection Summary

Manhole # S430__008MH

Location Address: **1501 Thames st** Cross Street: **s caroline st**

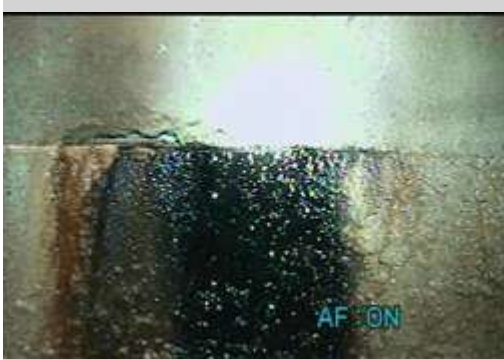
Defect 2

Barrel Material: **Precast Concrete** ☐ Parged
Shape: **Circular** Diameter: **48** (in.) Length: **0** (in.)
Condition: ☒ Sound ☐ Cracked ☐ Root Intrusion ☐ Loose Brick ☐ Deteriorated
Infiltration: ☐ None ☒ **Joint** ☐ Cracks ☐ Mortar ☐ Roots ☐ Wall

infiltration in joint of barrel

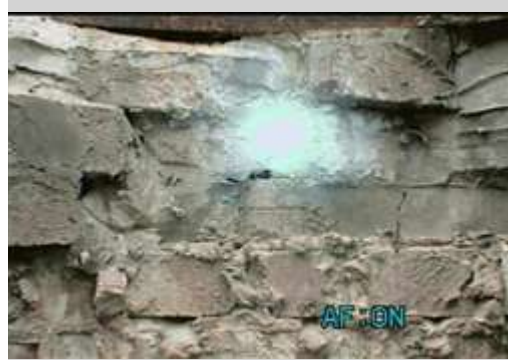
Defect 1

Condition: ☐ Sound ☐ Cracked ☐ Root Intrusion ☒ **Loose Brick** ☒ **Deteriorated**
Infiltration: ☒ None ☐ Joint ☐ Cracks ☐ Mortar ☐ Roots ☐ Wall

Chim_Det.

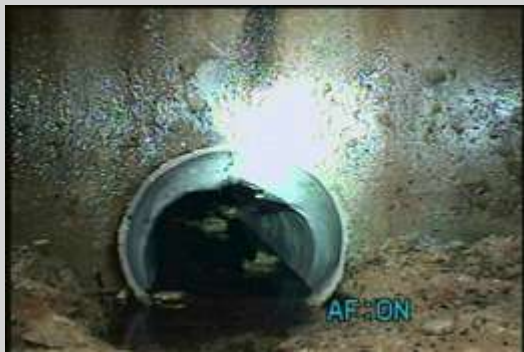
12 O'Clock Outflow

8 in. Circular Gravity Sewer
Pipe Out @ 12 O'Clock

Infiltration: **None** Pipe Seal Cond: **Unknown**
